**A CASE STUDY
SLOPE INSTABILITIES / REMEDIAL MEASURES
FOR A VIADUCT FOUNDATIONS**

Prof.Dr.Turan Durgunoğlu(1) ,Dr.Andrew Lord(2) ,H.Fatih Kulaç(3)

ABSTRACT

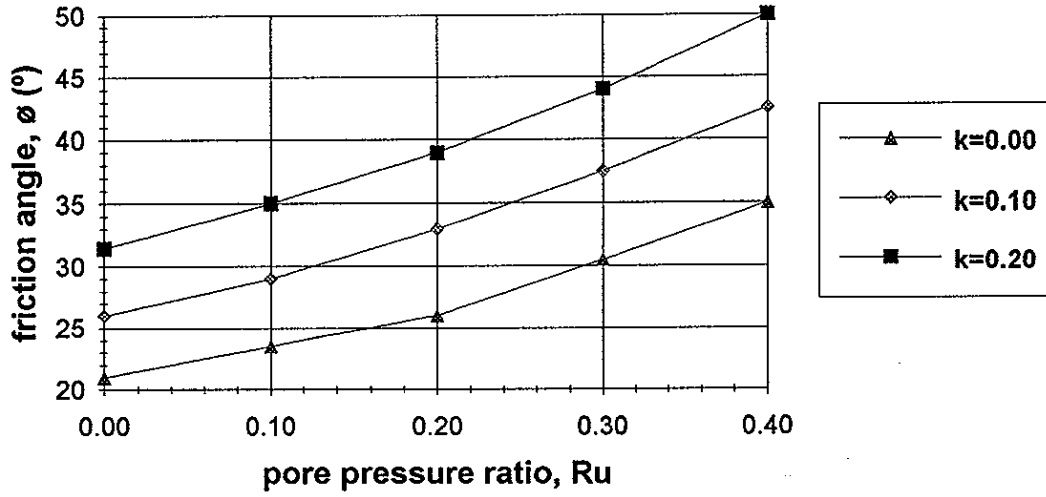
FIGURE 3 - Back Calculation Analysis for the topography of June 1988

The analysis for the loaded case (only the pier constructed) is presented in Figure 3. It is seen that for a possible range of values of pore water pressure ratio, $ru = 0.10$ to 0.20 , the required friction angle value for the analyzed slide surface under static conditions is $\phi_r = 23.7 - 26.6$ degrees. According to laboratory results, clay zones within the debris and mudstone resulted an average plasticity index value of $I_p = 15$. For this value, based on empirical relations developed by Kenney(1967), the residual friction angle is about $\phi_r = 24.0$ degrees.

As a result, an interface friction angle value of $\phi_r = 24.0$ is selected for use in the remedial design.

It is shown by the stability analysis that, increase in pore water pressure due to heavy rains with poor surface and subsurface drainage conditions and due to pier loading especially during minor earthquakes led to the instability of pier 8R and would cause the instability of other piers if the original design were not reassessed after the movement of pier 8R. For this purpose, a remedial design is developed mainly with below considerations;

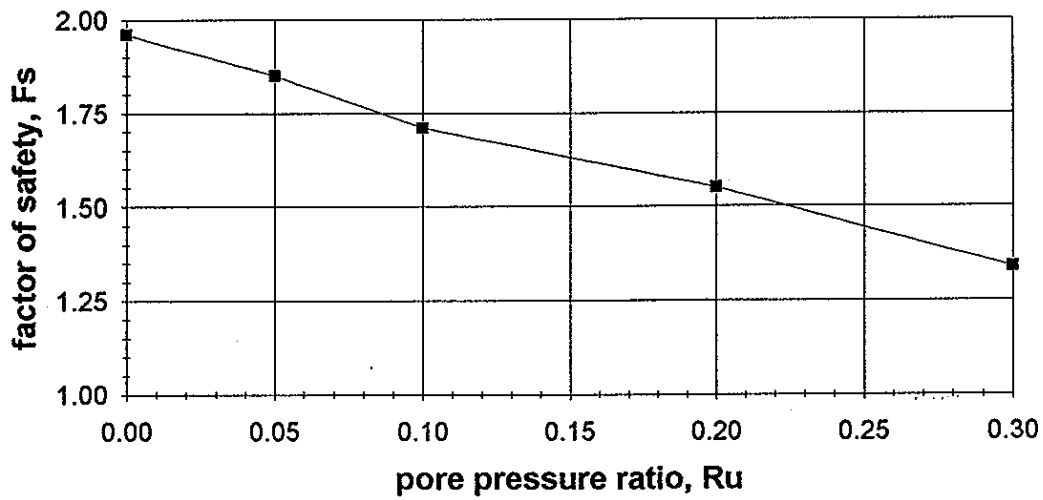
FIGURE 4 - Factor of safety under static conditions after remedial measure implementation ($k=0.00, \phi=24^\circ$)

Figure 4 presents the achieved factor of safety values against instability after the above remedial design measures implemented. A factor of safety of $FS = 1.85$ under static conditions and $FS = 1.01$ under a lateral earthquake coefficient of $k = 0.2$ is satisfied with the proposed remedial design considering that the pore water pressure ratio will be reduced to $ru = 0.05$ by proposed drainage system.

- * reduce gravity loads by means of regrading.
- * keep pore water pressures low by means of surface French drains and subsurface subhorizontal drains.
- * Eliminate external pier loading on the slope, by means of underpinning the constructed shallow foundation by micropiles.
- * Revise the design of not constructed piers and implement deep foundations by either large-diameter piles or micropiles considering the constructibility.
- * Following a strict construction scheme in order not to lead any instability during implementation of above recommendations.
