TWO CASE STUDIES RELATED TO THE LANDSLIDE REMEDIAL DESIGNS

2. GEREDE-ANKARA AND ANKARA PERIPHERAL MOTORWAY Km 63+400 BUĞRALAR LANDSLIDE

3. GEREDÉ-ANKARA AND ANKARA PERIPHERAL MOTORWAY Km 154+650 LANDSLIDE

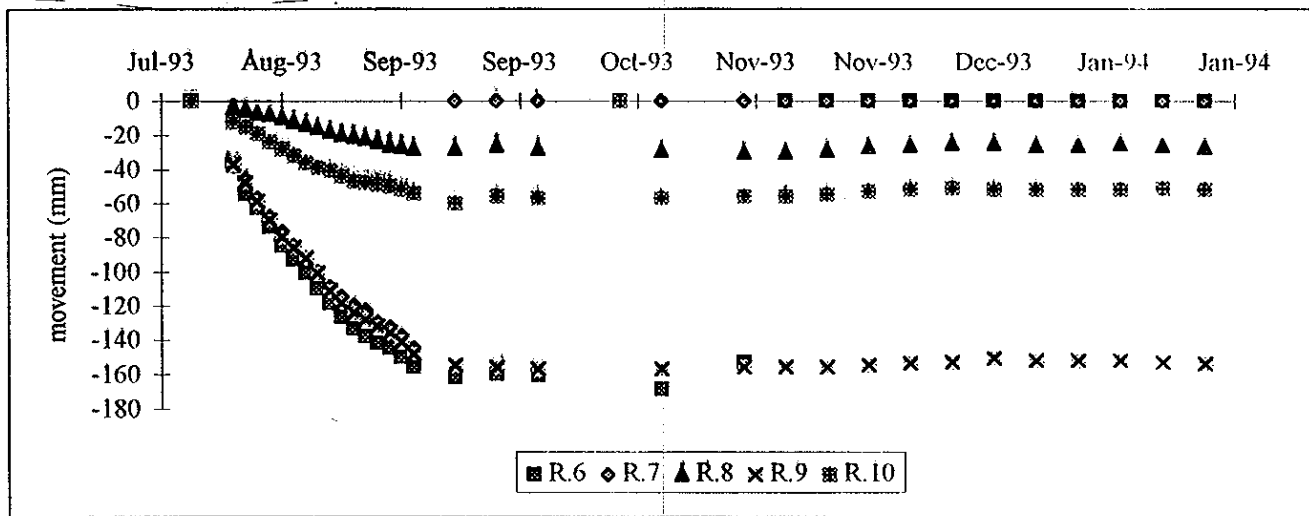
FIGURE 5. SURFACE BENCHMARK READINGS

time. As a short term measure based on the first available data it was proposed to perform some initial excavation at the top part of the landslide area in October 1993. A typical example is given in Figure 5. The surface benchmarks showed the tendency of slide to slowdown and stop after the excavation proposed in October 1993.
