Case History for Ground Improvement Against Liquefaction Carrefoursa Shopping Center – Izmit, Turkey

H.T.DURGUNOGLU, Bogazici University, Istanbul, Turkey
C. EMREM, Zetas Earth Technology Corp., Istanbul, Turkey
T. KARADAYILAR, Zetas Earth Technology Corp., Istanbul, Turkey
J. K. MITCHELL, Virginia Tech., Virginia Tech., Blacksburg, VA, USA
J. R. MARTIN, Virginia Tech., Blacksburg, VA, USA
C. G. OLGUN, Virginia Tech., Blacksburg, VA, USA

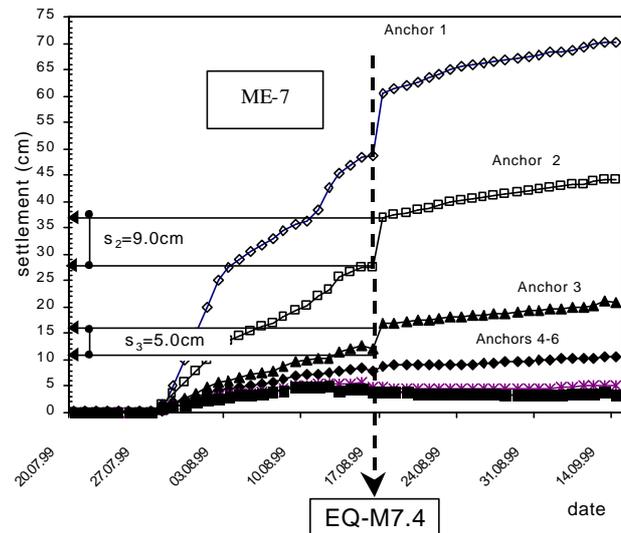
Figure 4. Time dependent settlement readings from magnetic extensometer at Lot C

Following field inspection, it was concluded that the observed surface water originated from the wick drains due to earthquake-induced pore pressure build-up in the sand layer. Three settlement measuring devices were in place at Lot C zone during the earthquake. By comparing pre- and post-earthquake readings, the earthquake-induced settlement of the sand layer could be closely determined. A typical records from one of the three magnetic extensometers installed at Lot C, are presented in Figure 4.

Each of the three installed magnetic extensometers consisted of five magnetic anchors installed at five-meter vertical intervals. During the quality control tests, 10 CPT tests were performed at Lot C area prior to jet grouting on 30/09/2001. CPTs 8, 9 and 10 were located closest to settlement columns 7, 9, and 8 respectively. The variation of tip resistance (q_c), and friction ratio (R_f) values with depth for a typical CPT data is shown in Figure 5. The estimated sand layer thickness for each CPT location ranged from 1.1 m to 1.5 m based on the soil classification procedure developed by Roberston (1988). To estimate the earthquake-induced settlement within the untreated sand layer, the difference between the settlement values recorded by anchors 2 and 3 were calculated. The elevation of anchors 2 and 3 do not correspond to the top and bottom of the sand layers (the anchors were installed in clayey and silty soil layers located about 2.5 m above and 1 m below the sand layer, respectively). Therefore, the estimated earthquake-induced settlements in the sand should be considered maximum values, as it is conceivable that a portion of the measured settlements may have occurred within the over- and underlying finer-grained soils. It is believed however, that the vast majority of the settlements measured between anchors 2 and 3 were from the sand layer. Based on this methodology, it is estimated that up to 4.0 to 4.5 cm of earthquake-induced settlement, corresponding to about 2.9 to 3.6% volumetric strain, respectively, occurred in the sand stratum.

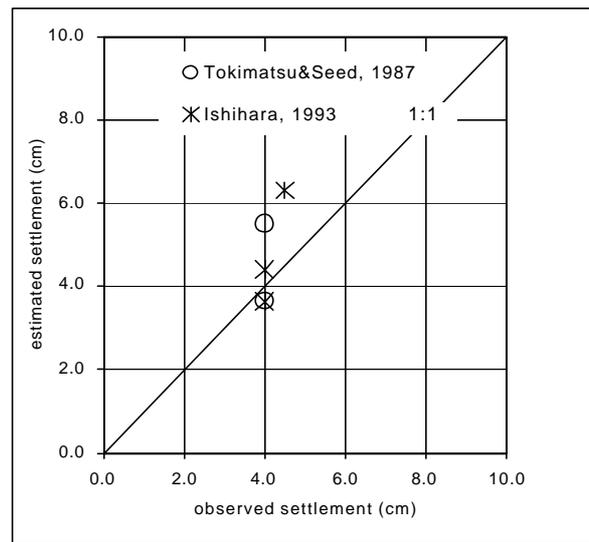
Figure 6. Comparison of estimated settlements

For purposes of comparison, existing settlement methods from the literature were used to assess predictive capability as determined by how closely they predicted the actual settlements. In using the CPT data for this purpose, the thin layer influence was considered as recommended by Robertson and Fear (1995), and a correction factor for cone resistance was also used in the calculations. Based on this methodology, Ishihara's procedure (1993), estimated about 4.8 cm of settlement. In order to compare the results from two in-situ tests, SPT blow count values obtained from boreholes made at Lot C are utilized and, Tokimatsu and Seed's procedure yielded an estimated average settlement of 4.6 cm. The results are summarized in Table 2 and plotted in Figure 6 for the purpose of comparison. For this site, it can be seen that both Ishihara's method utilizing CPT data and Tokimatsu and Seed's method utilizing SPT data provided close estimates for the observed settlements.

Procedure	Predicted Settlement (average value- cm)	Observed Settlement (average value- cm)
Ishihara (1993)	4.8	4.2
Tokimatsu and Seed (1987)	4.6

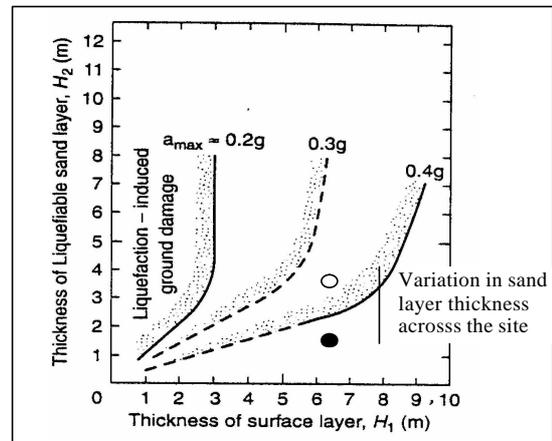
Figure 7. Conditions for occurrence and nonoccurrence of ground damage (After Ishihara, 1985; Adapted from Kramer, 1996)

Observations immediately following the earthquake of August 17, 1999 revealed that, within and/or in the close vicinity of the Carrefoursa site neither sand boils, nor any surficial ground damage occurred. Ishihara (1985) examined the soil conditions associated with various liquefaction-related damage reports and produced estimates of the thickness of the overlying layer required to prevent level-ground liquefaction-related damage as shown in Figure 7. Considering that approximately a 6.0

m thick layer of "unliquefiable soil" overlays the 1.5 m thick liquefiable sand layer at Lot C section, non-occurrence of surface manifestation is expected according to Ishihara as shown with the full circle in Figure 7.

Considering that the liquefiable sand layer thickness reaches to 4.0 m, Carrefoursa site is still within the "no ground damage" zone as presented by the open circle on Figure 7. It is also informative to note that Lot C and partly parking structure sections were the only area at the complex that had not been improved with jet-grouted columns prior to the earthquake. All other areas had been improved with both primary and secondary grids of grouted columns to reduce liquefaction susceptibility. Based on the differences in performance between the unimproved and the adjacent improved areas, it has been demonstrated that the jet-grouted columns have been effective in reducing liquefaction
