Soil Dynamics and Earthquake Engineering xx (0000) xxx–xxx

Correlation between ground failure and soil conditions in Adapazari, Turkey

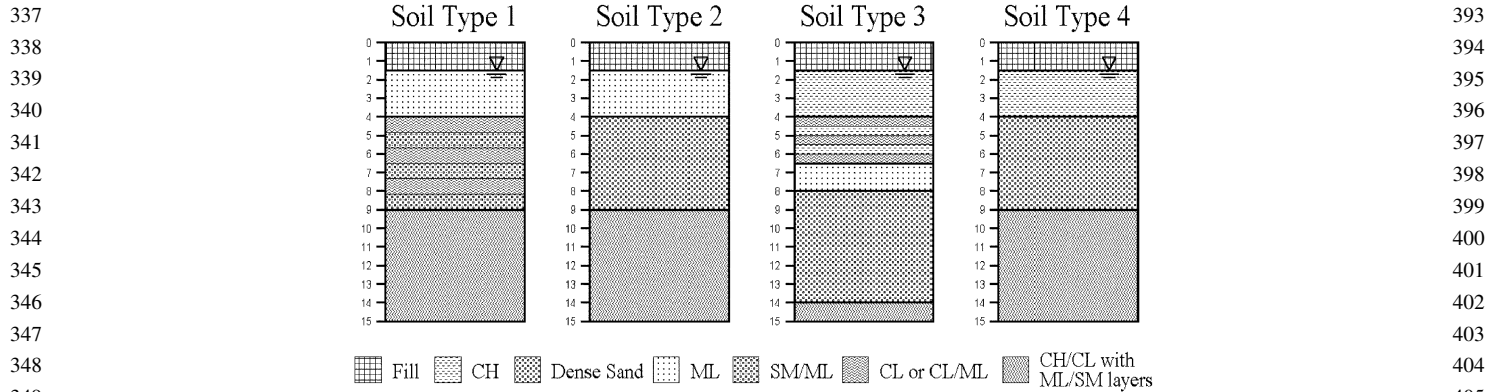
Soil Type 1. This site category is characterized by the presence of brown to reddish brown, loose non-plastic silt and sandy silt in the upper 4 m of the soil column. The thickness of this stratum across the area explored ranges

Fig. 2. Generalized subsurface soil profiles in downtown Adapazari.

Soil Type 2. This site category is similar to Soil Type 1, however, this category differs from Type 1 in that the soil directly beneath the brown loose silt is replaced by dense ($q_{c1N} > 160$ and $(N_1)_{60} > 30$), gray sand to a depth of approximately 9 m. Samples from this sand layer generally contained less than 5% fines and also contained less than 5% gravel. However, at a few locations retrieved samples had fine gravel contents as high as 27%. The mean grain size (D_{50}) of this stratum ranges from 0.4 to 1.7 mm.

Soil Type 3. The soil between approximately 1.5 and 4 m depth in this type profile is brown highly plastic silty clay underlain by interspersed lenses and layers of low to highly plastic silty clay and clayey silt. These plastic sediments continue to depths of approximately 7 m. The soil's color transitions from brown to gray at approximately 5 m. The values of LL range from 29 to 65%, but most are greater than 35%. Some of these soils have natural water contents that are close to or in excess of the LL. The thickness of each silt layer is generally less than 25 cm, but some were as thick as 50 cm. The combined thickness of these strata range from 1 to 3 m. The penetration resistances of the silts and clay-silt mixtures are low ($q_c < 2$ MPa, $q_{c1N} < 15$ and $(N_1)_{60} < 10$). From approximately 7 m to a depth of 8–9 m

Soil Type 4. This site category is similar to Soil Type 2, but differs in that the shallow loose brown silt characteristic of Type 2 is replaced by 1.5–4 m of medium to high plasticity silty clay. Thin layers and lenses (thickness < 0.5 m) of low plasticity clayey silt may lie within the upper 4–5 m of the soil column.

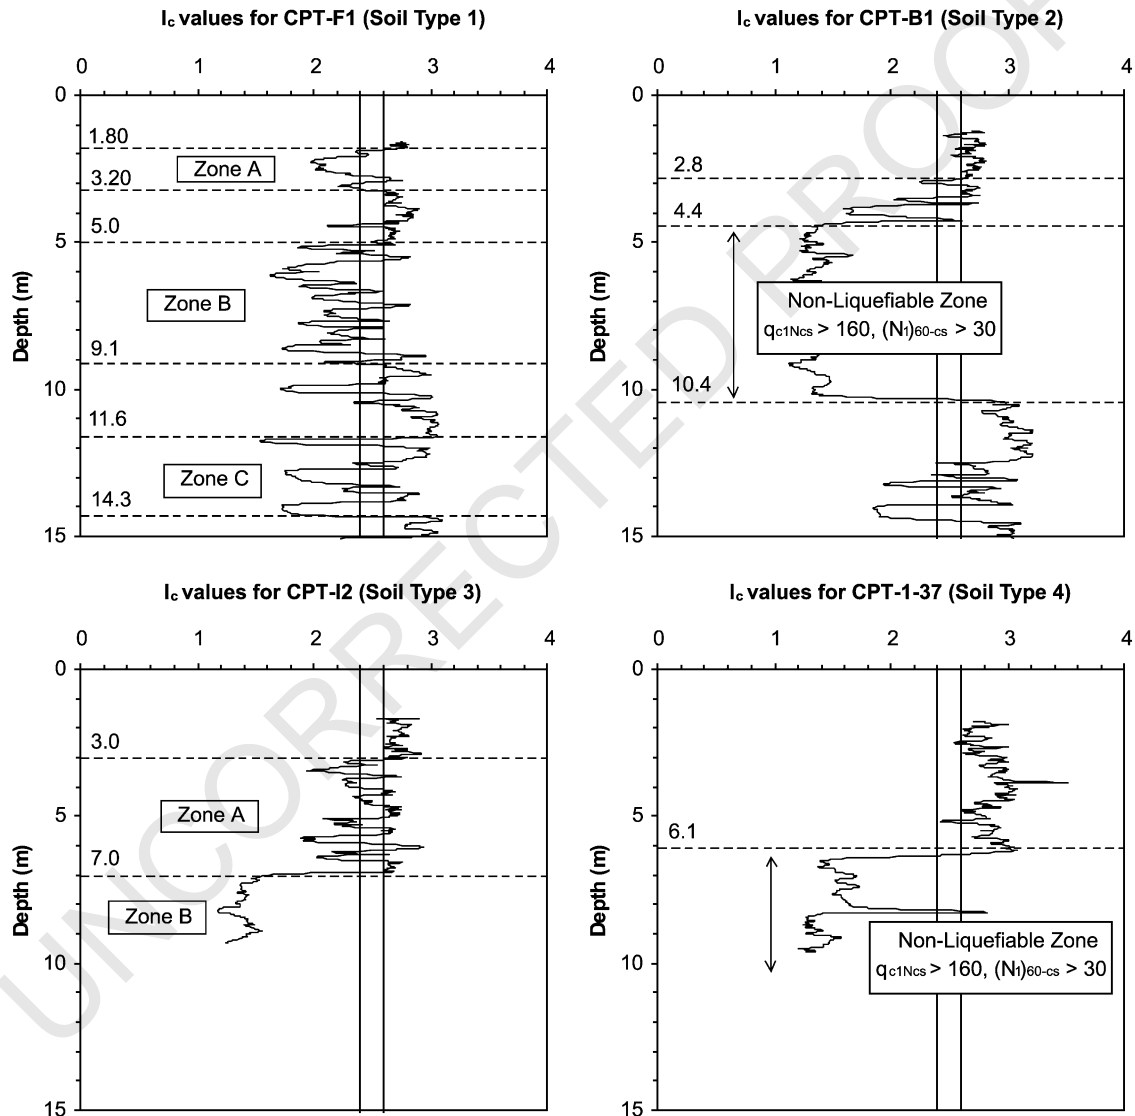
Fig. 3(a)–(d) show the values of I_c for representative CPT profiles of subsurface site category types 1–4, respectively, as well as the range of depth for which $I_c < 2.6$. In Fig. 3(a) (Soil Type 1 profile), three zones were identified that predominantly have I_c values below 2.6; these are from 1.8 to 3.2 m (Zone A), from 5.0 to 9.1 m (Zone B), and from 11.6 to 14.3 m (Zone C). Samples recovered in the vicinity of this CPT show that the soil in Zone A is brown, low plasticity silt. Although the characteristics of the samples comply with the LL and w_n/LL criteria of the Chinese criteria (i.e. $LL < 35\%$ and $LL > 0.9LL$), this soil

Fig. 3. Representative soil behavior index (I_c) values for (a) Soil Type 1 profile, (b) Soil Type 2 profile, (c) Soil Type 3 profile, and (d) Soil Type 4 profile.

As mentioned in Section 4, the stratum identified as Zone A has low penetration resistance, hence exhibits low CRR and can liquefy in the free-field at the PGA values that are estimated to have occurred in Adapazari (0.3–0.4g).

The soil strata in Zone B with $I_c < 2.6$ is silty sand to low plasticity silt. Silt samples retrieved from this range of depth have $LL = 28\text{--}31\%$, water content near the LL , and clay content ($\% < 5 \mu\text{m}$) close to or smaller than 15%. The penetration resistance of this material is highly variable, hence some of these layers may have liquefied in the free-field during the earthquake perhaps contributing together with the upper silt to ground failure. Finally, the deep sands found in Zone C have high penetration resistance ($q_{c1N} > 160$ and $(N_1)_{60} > 30$) and are too dense to liquefy.

The soil between 2.8 and 4.4 m ($I_c < 2.6$) in Fig. 3(b) (Soil Type 2 profile) has similar index properties and penetration resistance as the soil in Zone A of a Type 1 profile. Samples of potentially liquefiable brown silt from this layer generally met the LL and w_n/LL conditions of the Chinese criteria as mentioned above, whereas the amount of particles $< 5 \mu\text{m}$ is mostly greater than 15%. This analysis indicates that the sand strata between 4.4 and 10.4 m is susceptible to liquefaction as I_c is less than 2.6. However, given the high penetration resistance of the soil, this layer should not have liquefied during the earthquake.

The stratified silts and clays between 3 and 7 m, Zone A in Fig. 3(c) (Soil Type 3 profile), are the only sediment in the upper part of this subsurface profile that is susceptible to liquefaction ($I_c < 2.6$). Additionally, this section of the soil column has a penetration resistance for which the CRR is smaller than the expected CSR that was imposed by the earthquake. Some soil samples within this stratum have $LL < 35\%$ and $w_n/LL > 0.9$. Although the amount of particles smaller than the $5 \mu\text{m}$ is consistently greater than

15%, this soil may have liquefied during the earthquake. The stratum of gray poorly graded sand, Zone B in Fig. 3(c), has high penetration resistance characterized by $q_{c1N} > 160$ and $(N_1)_{60} > 30$ and is too dense to liquefy.

With the exception of thin silt lenses at approximately 2.5 and 5 m, the I_c value for the soil profile shown in Fig. 3(d) (Soil Type 4 profile) is greater than 2.6 which indicates a sediment that is too clayey-rich to liquefy. Soil borings near CPTs at similar sites indicate that the upper soils were of too high plasticity to have liquefied. However, weak clayey soils not prone to liquefaction could still be susceptible to significant strength loss upon cyclic loading, so ground failure at these sites cannot be absolutely precluded.

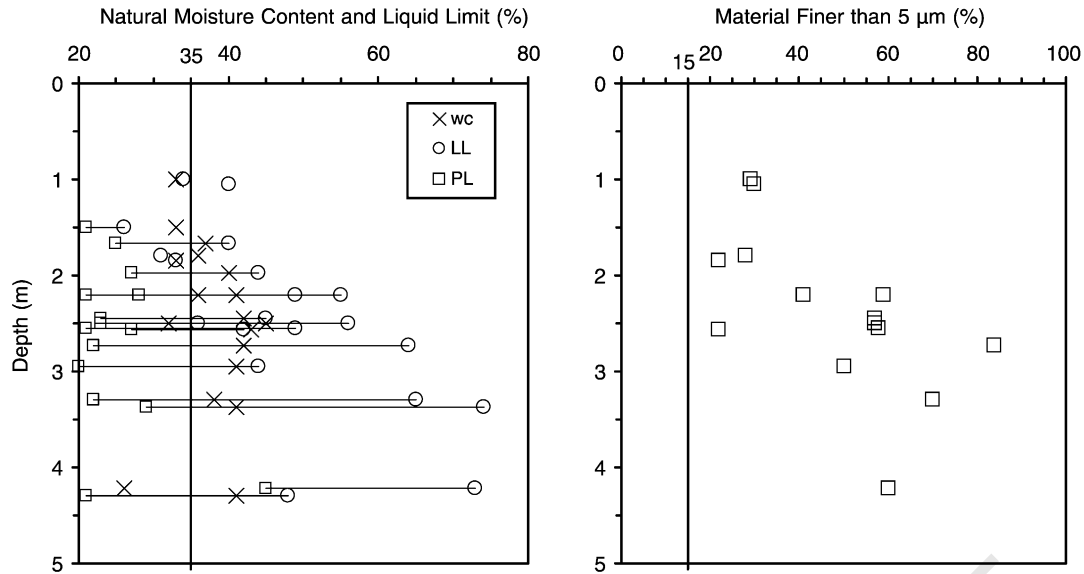
Fig. 4. Soil characteristics based on soil index tests of samples retrieved at Site C in the range of 1.0 and 5.0 m (from data presented in Refs. [2,3].

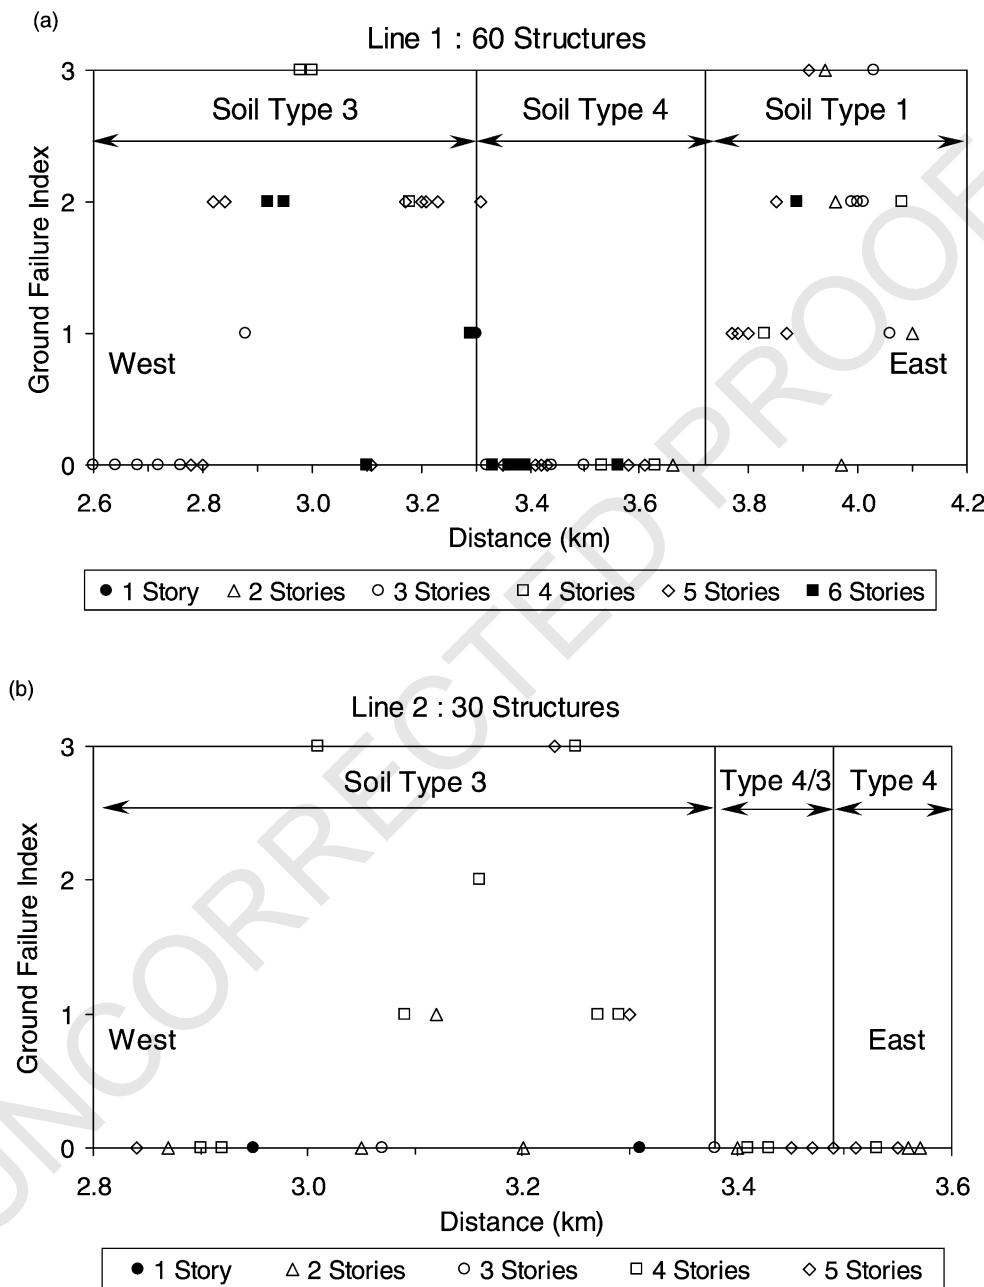
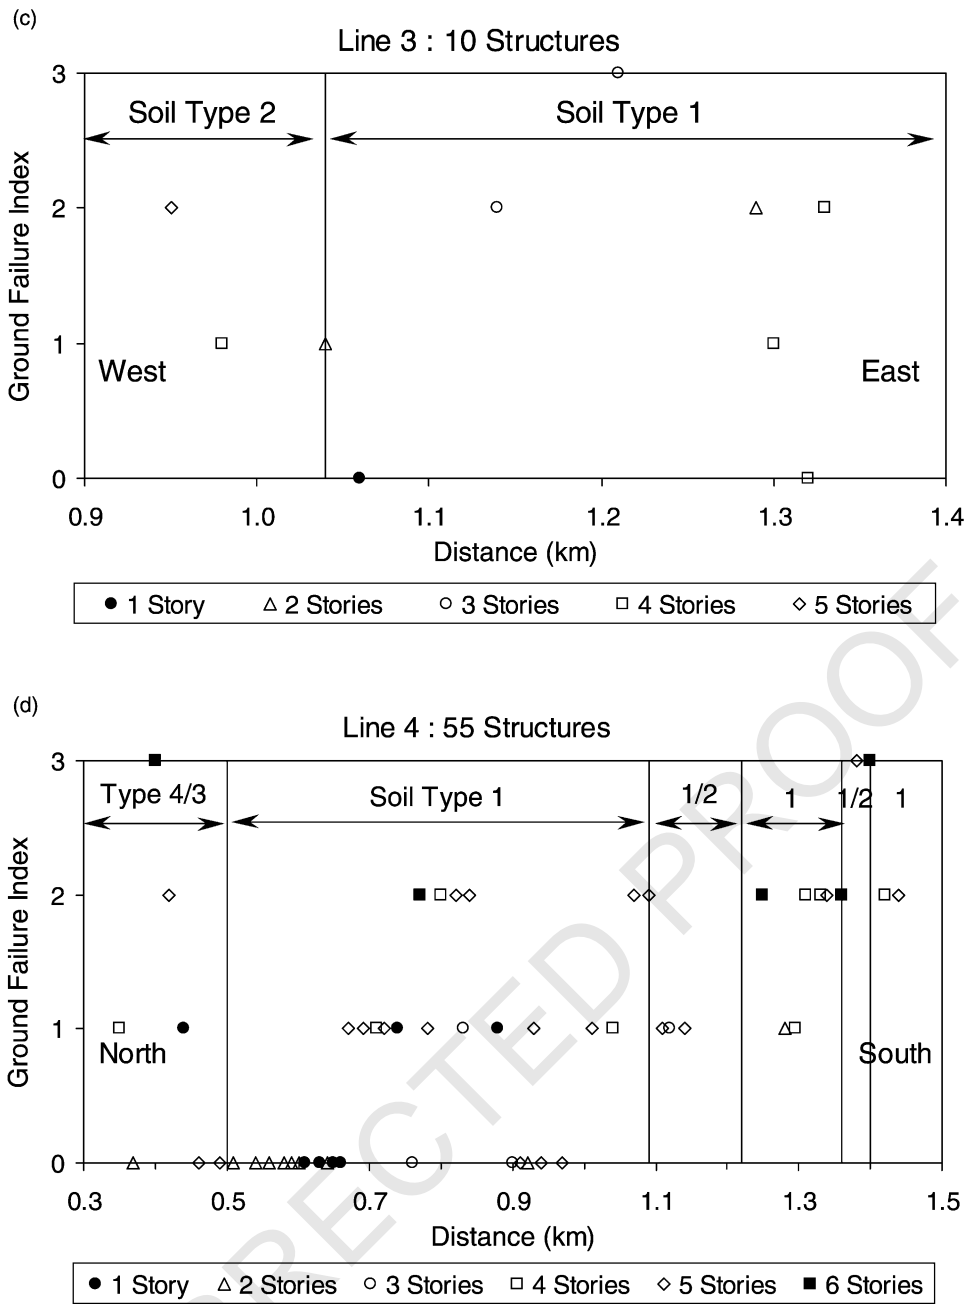
The distribution of ground failure index (Table 1) along the portions of the survey lines 1–4 shown in Fig. 1 is shown in Fig. 5(a)–(d), respectively. As can be seen, ground failure was predominantly observed where the subsurface soil conditions are Soil Types 1, 2, and 3. Where Soil Type 4 soil conditions exist, ground failure was minor or absent. A slash (/) indicates transition between soil types.

Ground failure appears to be most prevalent where Soil Type 1 and 2 conditions exist, i.e. between approximately 3.75 and 4.2 km along Line 1 and 0.4 and 1.1 km along Line 4. The presence of the shallow, loose reddish brown, low plasticity silt in Soil Type 1 and 2 profiles is believed to have a significant influence on the observed ground failure. The absence of ground failure in some of the areas where the soil conditions are Type 1 may be attributed to variations

The relatively few buildings with reported ground failure observed along the section of Line 3 shown in Fig. 1 (see Fig. 5(c)) is due to the high number of buildings with high index of structural damage (total collapse). Foundation

The distribution of ground failure index presented in Fig. 5 has also been classified according to the number of storeys of the building surveyed. In general, it can be noted that the severity of ground failure appears to be most strongly influenced by the type of soil profile over which the structure is founded. At sites where soils susceptible to liquefaction were present (e.g. predominantly Soil Type 1

Fig. 5. (a) Ground failure index and soil profile type distribution along Line 1; (b) ground failure index and soil profile type distribution along Line 2; (c) ground failure index and soil profile type distribution along Line 3; (d) ground failure index and soil profile type distribution along Line 4.

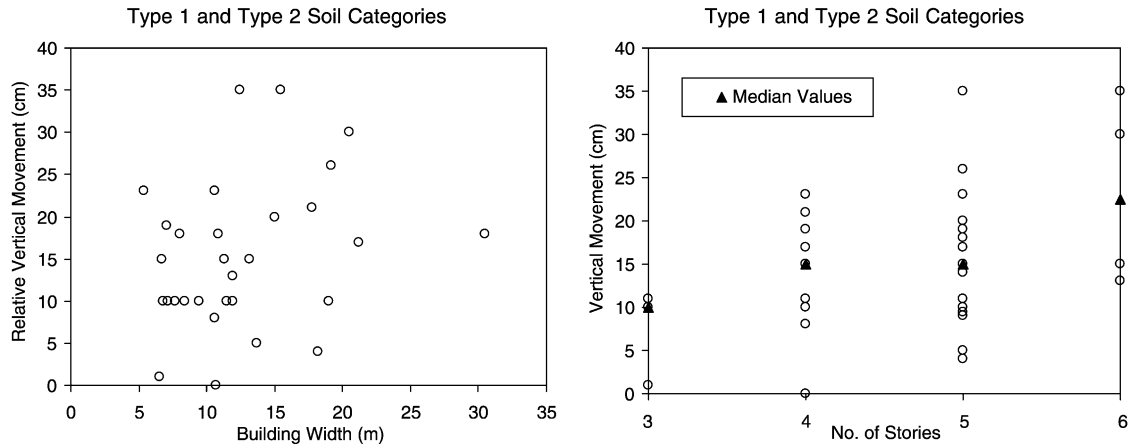
As described earlier, the reported ground failure index is principally a function of measured relative vertical displacement and tilt of the building. The average measured relative vertical displacement is shown in Fig. 6 as a function of building width and number of storeys (which, in turn, is related to contact pressure) for buildings founded on soil profiles that classify as Type 1 and 2. Buildings that

As can be noted in Fig. 6(a), most of the structures' foundation width is in the range of 5–20 m. Within this range, most structures experienced vertical displacement

Fig. 6. Relationship between observed vertical building movement relative to the adjacent ground and (a) building width, and (b) number of storeys of the structure.

between 0 and 30 cm, and a relationship between these two factors is not apparent. However, the amount of vertical displacement of the building relative to the surrounding ground is found to be dependent on the building's number of storeys as shown in Fig. 6(b). There is a trend for buildings with more storeys (or analogously, greater contact pressure) to undergo more relative vertical displacement than shorter buildings. Regardless of the width of the foundation, on average, the taller, heavier buildings experienced greater vertical movement than the smaller, lighter buildings.
