A Case Study On Slope Failure in A Sanitary Landfill

H. Turan Durgunoglu

Turhan Karadayılar

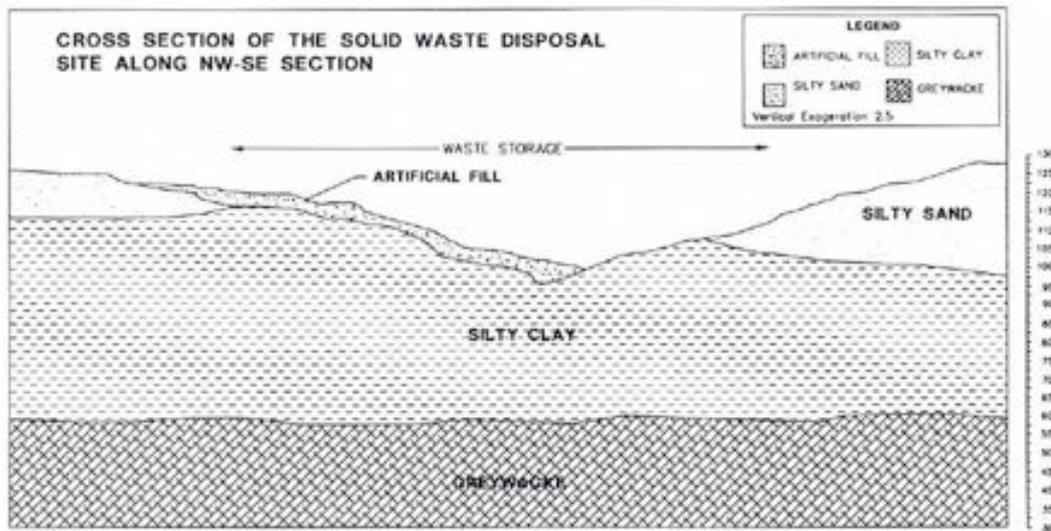
Figure 2. Schematic cross section of soil profile.

It has been observed that the local geological formation consists of alternating silt and sand lenses erratically distributed in the clayey subsoil. Fill and vegetative soil is present at the surface with thicknesses varying between 0.5-3.0m at maximum reaching to 9.0m. Silty sand is present at the upper portions of the side slopes of the storage area. The surface of the waste storage area is covered with a silty clay, which has silt and sand lenses within its formation. Below these alluvial deposits, at a depth of ~30.0m, greywacke is present. No groundwater is detected within the subsoil during the investigations. The clayey subsoil located at the surface prevents the intrusion of surface water into the subsoil. The schematic cross section of the soil profile is given in Figure 2. Since a closed coal mining site partly occupies the disposal site, the natural topography has been altered to great extent.

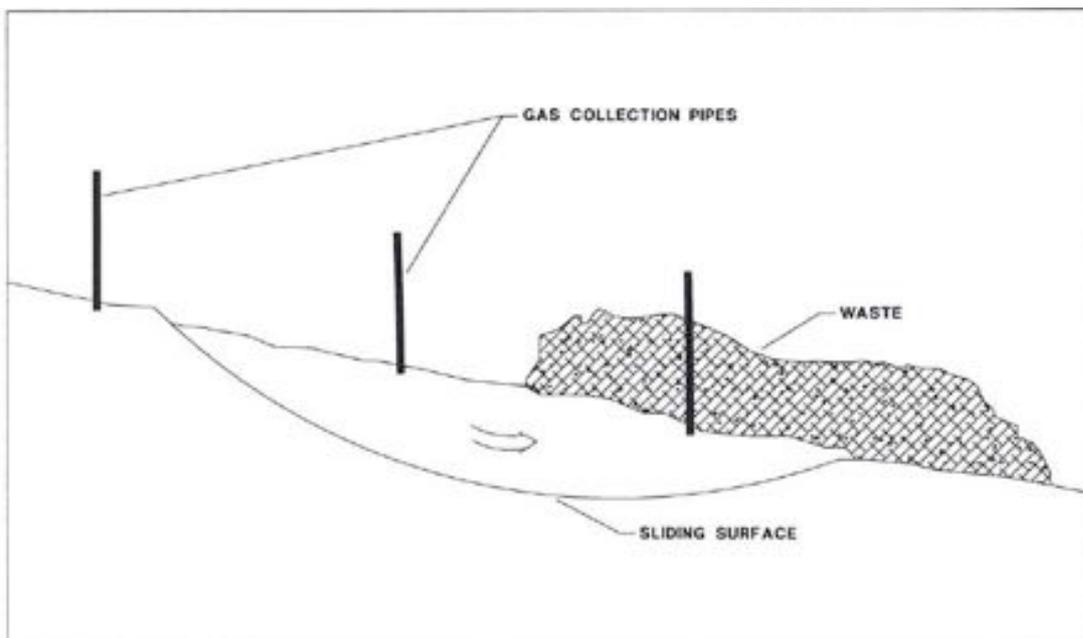
Figure 3. Typical geometry of sliding.

water problems were encountered during the excavations performed during construction. The base of cell BA-1 which is planned to be the initial storage unit of the first stage has been covered with a 30 cm clay liner and 2mm HDPE geomembrane. It has been opened to waste storage by January 1995 and a sliding movement was initiated by April 1995. The movement has continued for nearly two months resulting in ~300mm vertical and horizontal displacement and then it has accelerated for a period of one month totalling a displacement of ~1700mm and finally diminished and stayed constant by the end of four months. The schematic cross section of the sliding is shown in Figure 3.

It has been observed from field investigations that the sandy clay layer overlying the clayey subsoil is exposed to the ground surface at the upper portions of the slope due to excavations performed during construction. Precipitation permeated this formation and caused a rise in pore water pressure in vertically and horizontally connected silt and sand lenses within the clayey subsoil finally resulting in sliding. Such a saturation process in the sand layer which contributed to formation of a potential sliding surface within the clayey subsoil is mainly due to extensive rainfall during the period of Winter-Spring 1995, preceding the failure. Therefore the main reason of sliding is determined to be the rise pore water pressure in the subsoil.

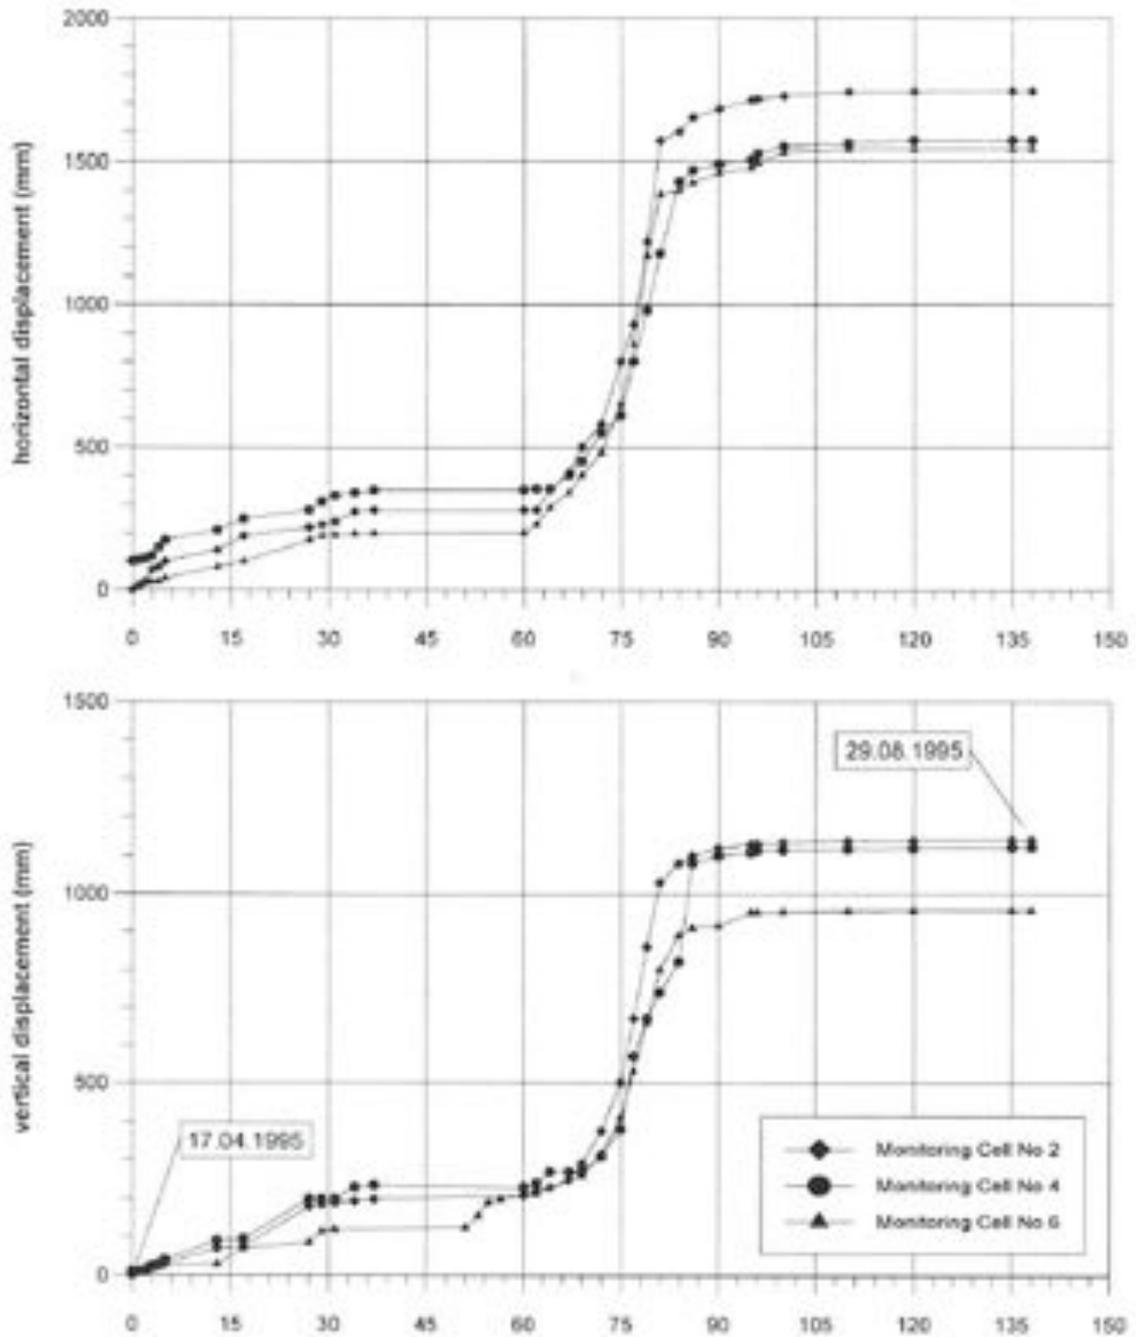
Figure 4. Monitoring data of horizontal and vertical movements.

The effect of sliding on the operational system of the landfill has been investigated. It has been observed that extensive displacements due to sliding have resulted in the breakage of the leachate collection and removal system. The resulting movement (1000mm vertical and 1500mm horizontal displacement) of a sliding block of 320 m width has caused the leachate collection and removal pipes to break. Several investigations have been performed for the evaluation of the sliding movements and its resulting effects. The monitoring data of vertical and horizontal movements during the period of sliding movements are given in Figure 4 (Özaydin et. al., 1995).
