Case History for Ground Improvement Against Liquefaction Carrefoursa Shopping Center – Izmit, Turkey

H.T.DURGUNOGLU, Bogazici University, Istanbul, Turkey
C. EMREM, Zetas Earth Technology Corp., Istanbul, Turkey
T. KARADAYILAR, Zetas Earth Technology Corp., Istanbul, Turkey
J. K. MITCHELL, Virginia Tech., Virginia Tech., Blacksburg, VA, USA
J. R. MARTIN, Virginia Tech., Blacksburg, VA, USA
C. G. OLGUN, Virginia Tech., Blacksburg, VA, USA

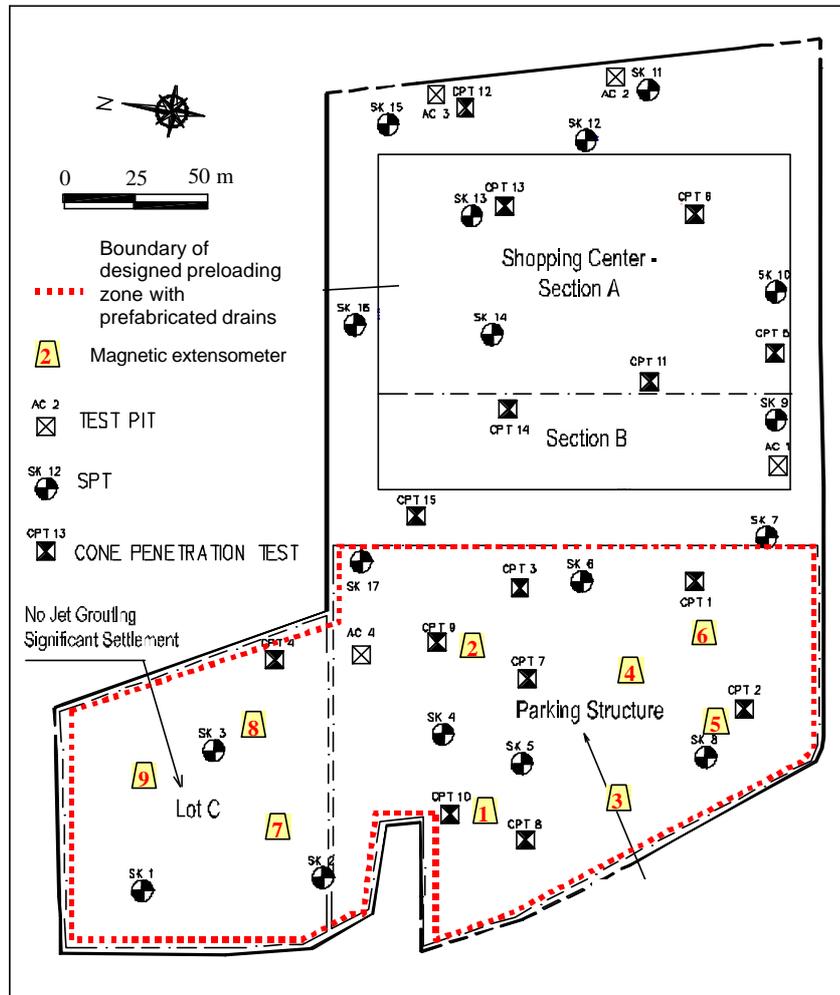
Figure 2. General lay-out of the shopping center and preliminary soil investigation locations

Subsoil investigations for the proposed facilities included Cone Penetration Testing (CPT), Standard Penetration Tests (SPT), and trial pits (Zetas, 1998). The locations of the investigations are shown in Figure 2.

To provide a clearer understanding of the findings of the field reconnaissance, the status of the construction of the shopping center facilities at the time of the 17 August 1999 earthquake is summarized below. While reviewing these notes, it may be helpful to examine Figure 2:

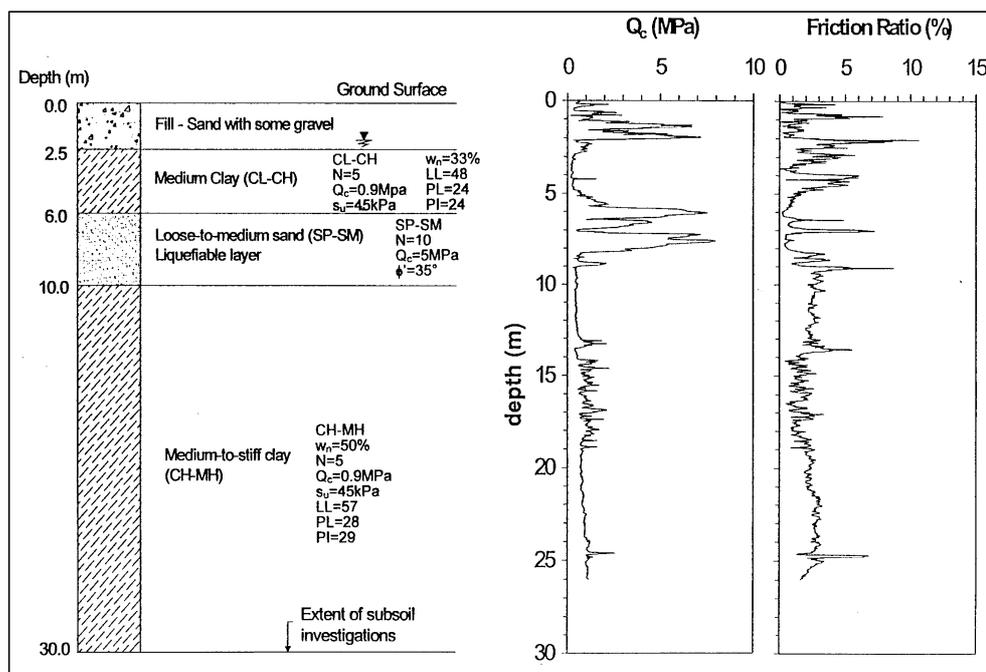
Figure 3. Typical geotechnical section

Based on the geotechnical data shown in Figure 3, the allowable soil pressure for shallow foundations (without consideration of settlements), was estimated at $q_{all}=75$ kPa, using a safety factor of 3.0 against bearing capacity failure.

The site is underlain by a gravelly sand fill that extends from the ground surface to a depth of about 2.5 m. The fill is underlain by a medium clay stratum that extends from a depth of 2.5 m to 6.0 m. Below the clay, a stratum of fine silty sand is encountered at a loose-to-medium density. The thickness of this sand layer ranges from 4 m to 1 m across the site. Below the sand, is a layer of medium silty clay that extends from 10 m to a depth of more than 30 m, where the exploration was terminated. The ground water table was found within 2.6 m of the ground surface throughout the site. A representative geotechnical profile is shown in Figure 3.
