Soil Dynamics and Earthquake Engineering xx (0000) xxx–xxx

Correlation between ground failure and soil conditions in Adapazari, Turkey

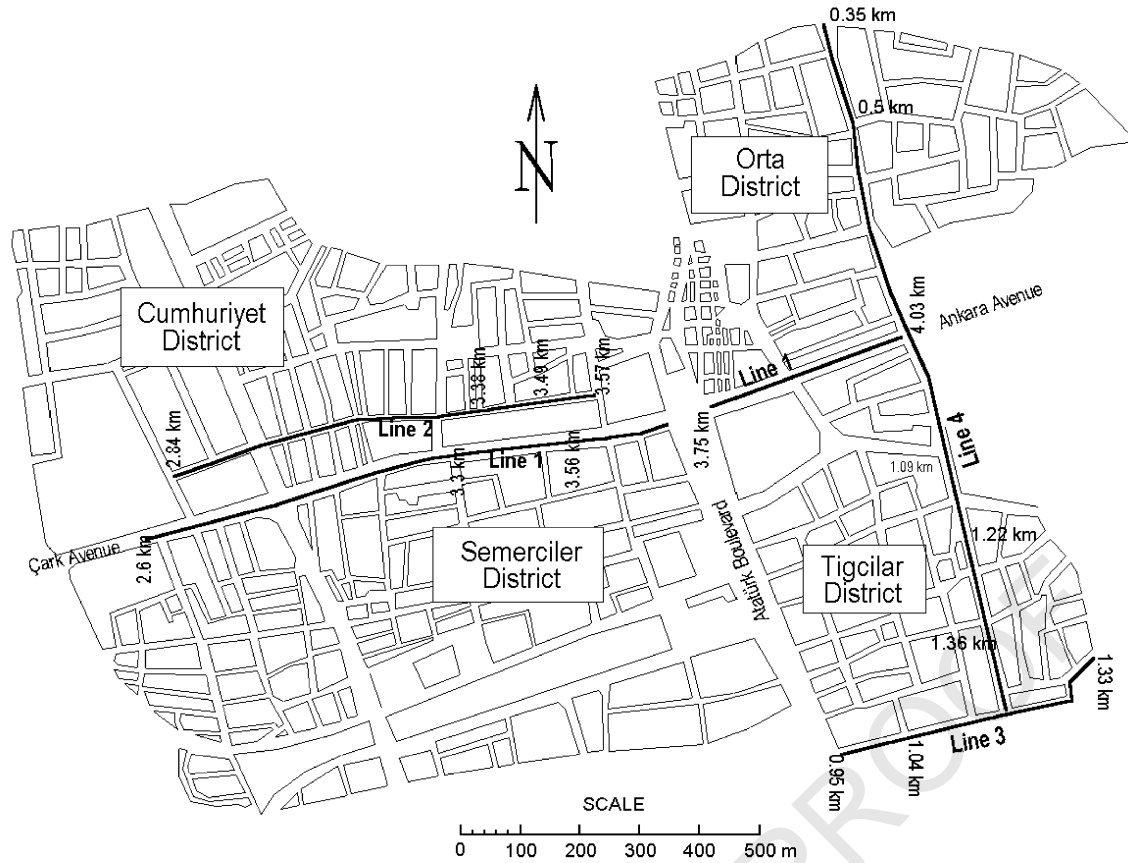
181 A map of four central districts located in the downtown
182 area of Adapazari is reproduced in Fig. 1. Also shown on the
183 map are survey lines 1–4, along which building damage
184 indices were recorded about 2 weeks after the August 17,
185 1999 Kocaeli earthquake. Subsurface soil conditions along
186 these survey lines were developed through the analysis and
187 interpretation of the 59 CPTs and 15 exploratory borings
188 with closely spaced SPT performed along these lines for this
189 study [3].

Fig. 1. Map of four downtown districts in Adapazari and location of survey lines.
